## **IV. OPTION 1: RETROFIT EXISTING STRUCTURE AND MASONRY**

### **1. GENERAL INTRODUCTION**

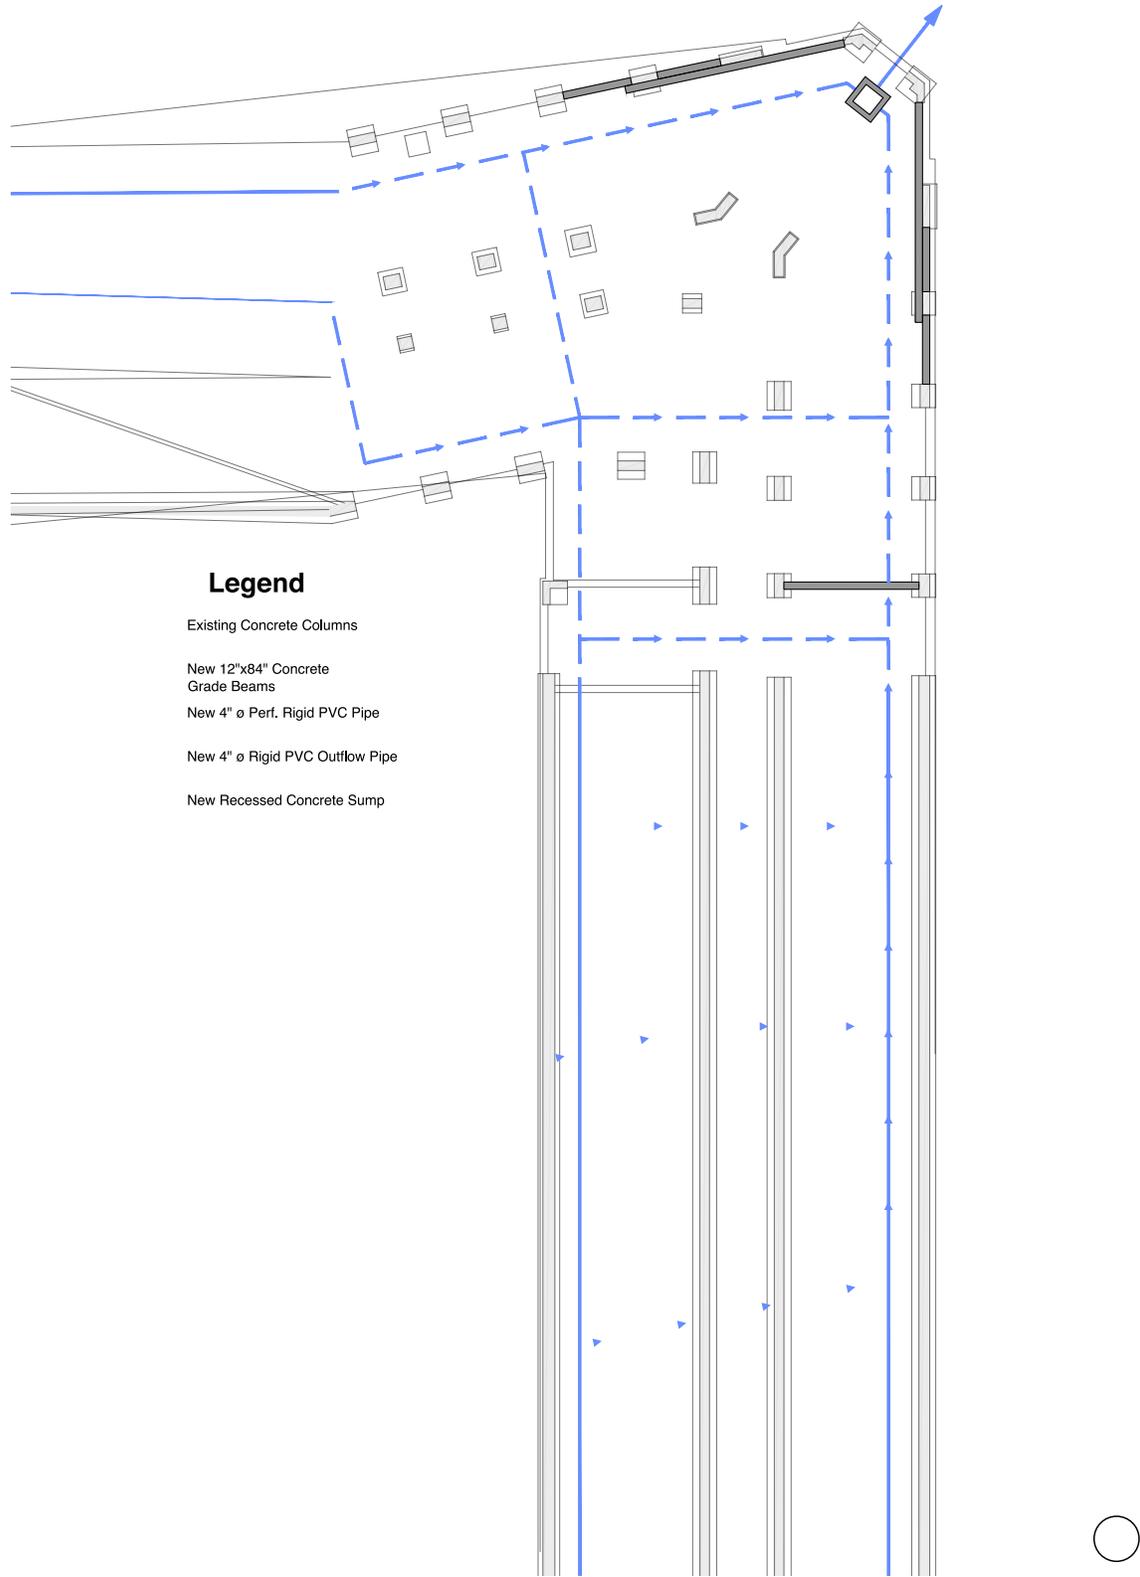
**Figure IV-2.2(1): Structural Reinforcing of Foundation System**

Very wet soils occur in the crawl space under the building, with a small, continuous stream running through this space. Consequently, the foundations suffer variable degrees of corrosive spalling and efflorescence, indicating moisture absorption into the concrete.

With regard to structural adequacy, analysis indicates that the foundation system is generally adequate for resisting vertical gravity loads, but does not suffice to resist lateral loads. Consequently, some beefing-up is warranted. In brief, this consists of the addition of several large grade beams, as described in greater detail in subsection IV-2.2.2.

The structural enhancement of these foundations consists of adding new concrete grade beams at the building's SW and SE corners, as well as near the entry portico, as shown in Figure IV-2.2(1). The new grade beams should be 12" thick and 84" tall, extending downward 7'-0" from the undersides of the ground-level concrete floor beams.

To limit the destruction of the new grade beams by moisture absorption, as is occurring with the existing foundations, the grade beams should incorporate several measures. First, any reinforcing should be of stainless steel, or hot-dipped galvanized steel as a minimum, to control corrosion. To limit shrinkage cracks and resultant moisture entry, a low shrinkage, low-water concrete mix with polypropylene fiber reinforcing and Kryton KIM admixture should be used.
