## **IV. OPTION 1: RETROFIT EXISTING STRUCTURE AND MASONRY**

### **1. GENERAL INTRODUCTION**

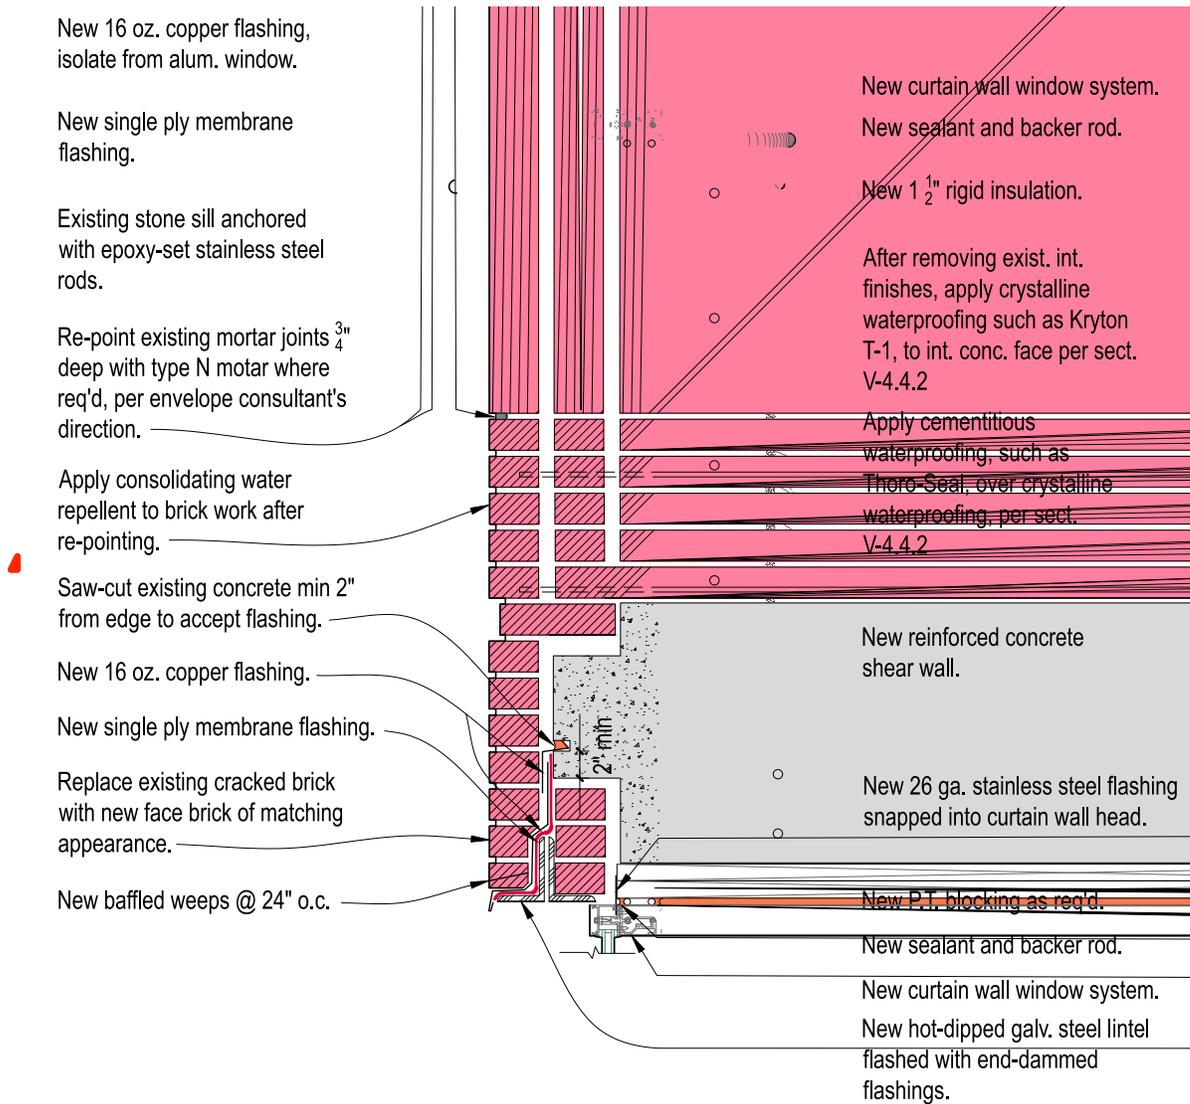
**Fig. IV-4.7(1): Window-Head Lintel Replacement and Flashing**

Although many of the existing lintels are still in decent condition and could provide several decades of additional life, their current un-flashed configuration contributes to scattered interior leakage, and the scope of this retrofit project warrants replacement of the outer, accessible lintels as part of this approach. This work is depicted in Figure IV-4.7(1).

In brief, this work must begin by placing the interior concrete walls and brick anchors above, and will also probably require temporary bracing to maintain stability. About 5 brick courses above the lintels need to be removed to access the steel double-lintels. The outer of these should be replaced with a new, hot-dipped galvanized steel lintel. A saw cut should be made into the concrete lug above the heads to receive the upper portion of a 2-piece flashing. A membrane flashing, consisting either of a single-ply membrane such as Cetco Core-Flash 60, or a self-adhered membrane, such as Grace Vycor Plus, should then be adhered over the lintel and up the inner brick and concrete to the saw-cut. A 2-piece copper flashing should then be installed as shown in Figure IV-4.7(1), and the brick should be reinstalled, using type N mortar. Baffled weeps spaced 24" apart should be included for drainage.

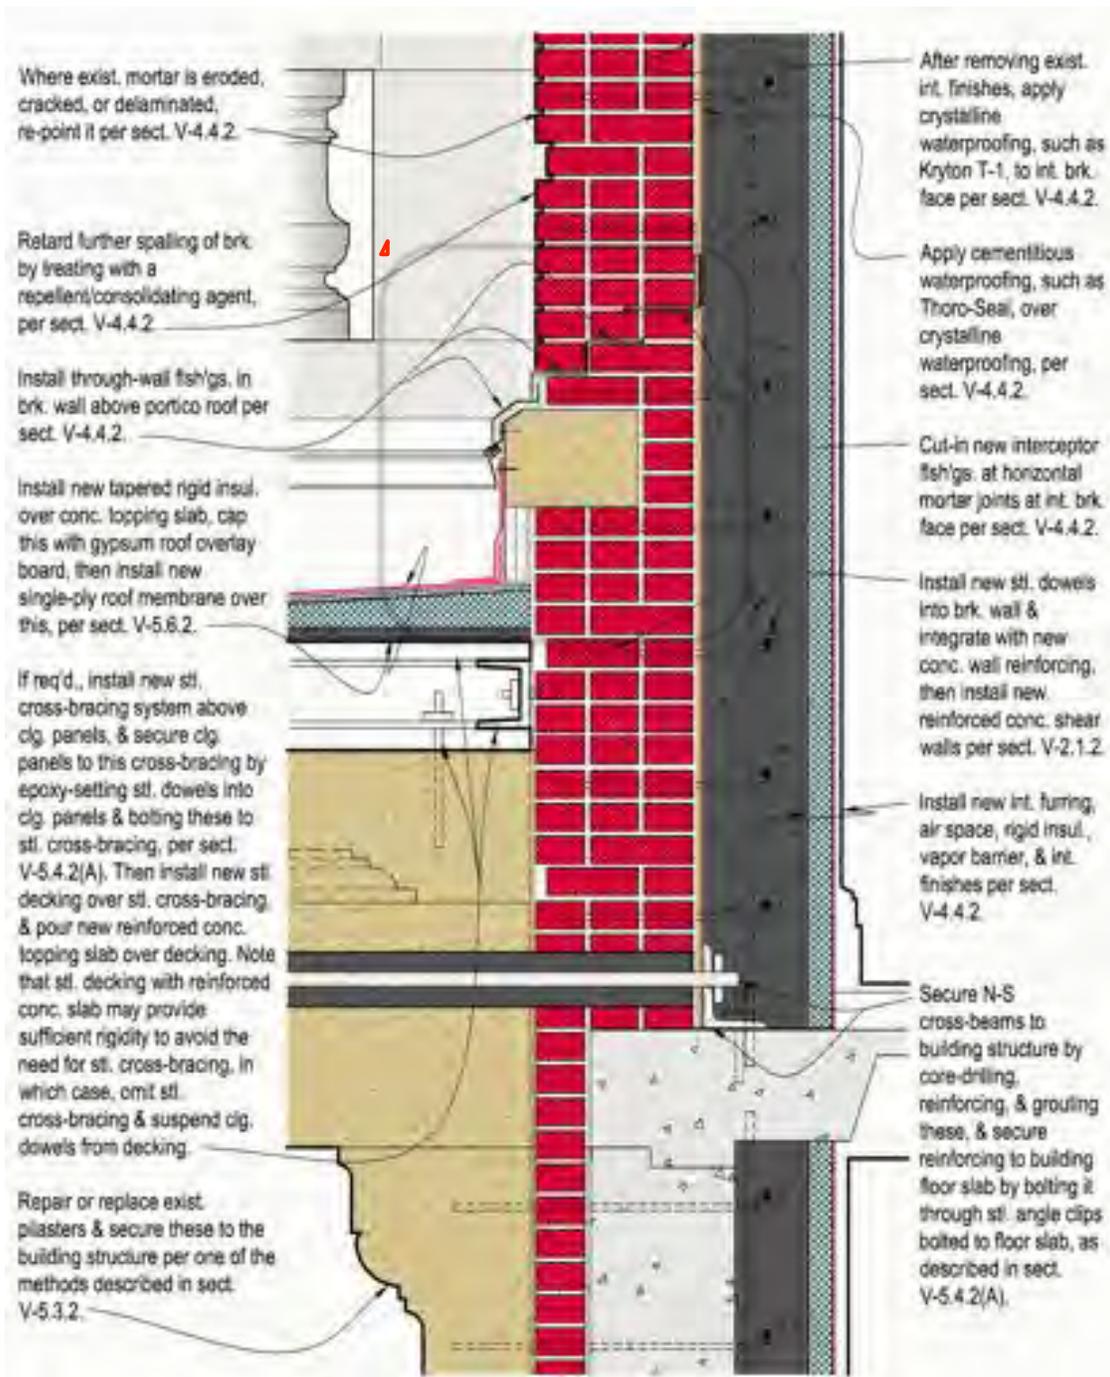
**Figure IV-5.6(4): Retrofitting of Through-Wall Flashings Above Portico Roof**

Note that this drawing is excerpted from the 12/31/10 report, and its notes reference sections of that report. Further, this drawing does not entirely align with the work described here. For example, the stone portico elements shown should be changed to pre-cast concrete.
